# A Practical Guide to MR Imaging Safety: What Radiologists Need to Know<sup>1</sup>

**RadioGraphics** 2015; 35:1722–1737

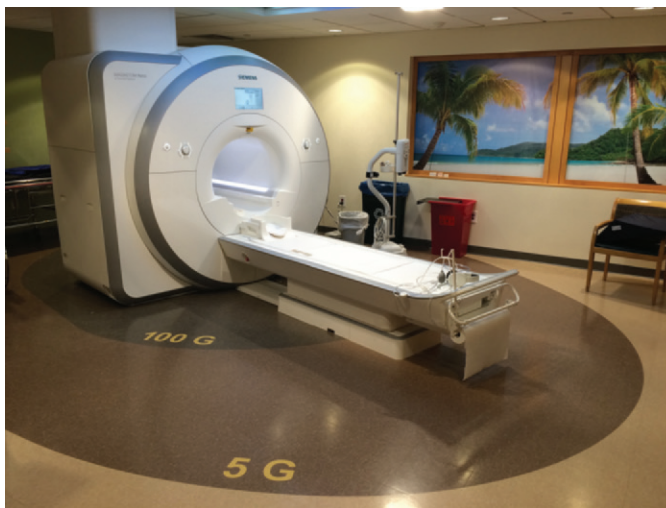
**Figure 1.** Photograph shows the 5-G line along the floor of one of our MR imaging systems. Newer magnets, such as this 1.5-T unit, use active shielding to bring the 5-G line as close as possible to the bore.

U.S. Food and Drug Administration (FDA) guidelines refer to a magnetic field of 5 G (0.0005 T) as the upper limit where the field strength is of no potential concern for the general public, including persons with implanted electronic devices (4). A line called the 5-G line is often drawn around the bore to show this limit (Fig 1).

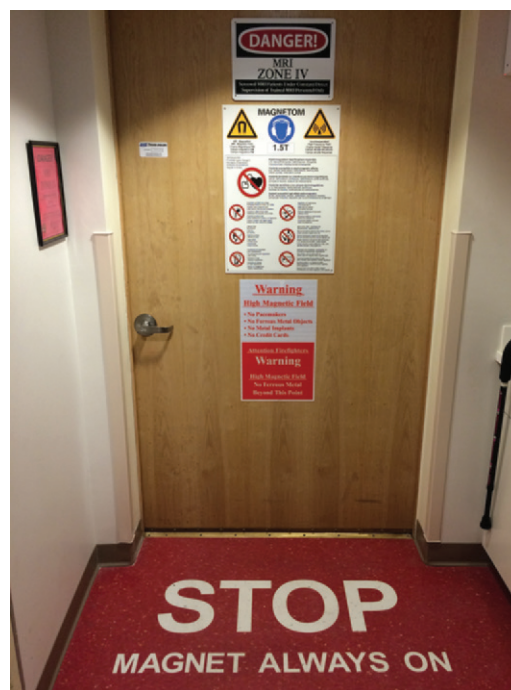
**Figure 3.** Entrance to one of our magnet rooms, designated as zone IV, is labeled with standard signage, including a reminder that the magnet is always on.

**Zone IV.**—This is the MR imaging unit magnet room itself and therefore is the highest-risk area. This zone should be clearly marked (with a red light and a sign stating that the magnet is always on) as potentially hazardous because of the strong magnetic field (Fig 3). Persons accessing zone IV must be under the direct visual observation of MR imaging personnel.
